STRESS CORROSION CRACKING OF TITANIUM ALLOYS

PROGRESS REPORT: JULY 1 - SEPTEMBER 30, 1964

DP(NASA)-941
Special Distribution

E. I. DU PONT DE NEMOURS & COMPANY
SAVANNAH RIVER LABORATORY
AIKEN, SOUTH CAROLINA

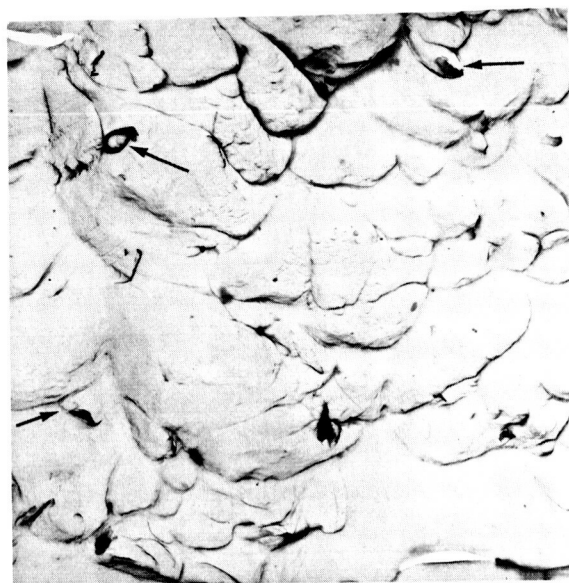
a. Metallographic section. Note the large number of beta particles.

b. Tensile rupture surface. Note that little or no beta phase can be seen. Arrow points to possible beta particle.

FIG. 7 COMPARISON OF BETA PHASE PARTICLES IN METALLOGRAPHIC SECTION AND TENSILE RUPTURE SURFACE. The lack of evidence of beta phase in the tensile rupture indicates that the alloy had no preference for fracture along beta-alpha phase boundaries or through beta particles. 3200X

Fractography of the rupture surfaces on tensile samples showed that failure occurred predominantly by shear. As shown in Figure 7a and b, comparison of the number of beta phase particles in a metallographic section with the number in the rupture surface indicated that fracture occurred through the alpha matrix with no preferential cracking along beta-alpha phase boundaries or through beta phase particles. This is in contrast to the preference for hot-salt stress corrosion cracking to occur along beta-alpha phase boundaries shown in Figure 10b.

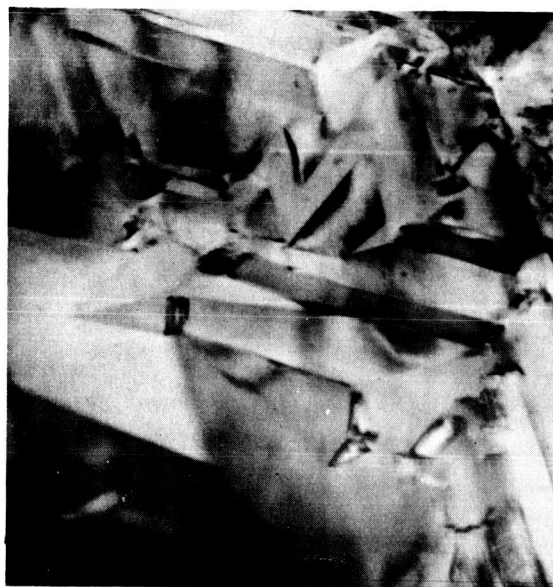
FIG. 8 ELECTRON TRANSMISSION MICROGRAPHS OF Ti-8Al-1Mo-1V ALLOY IN THE DUPLEX-ANNEALED CONDITION

Transmission electron microscopy of thin foils of duplex-annealed Ti-8Al-1Mo-1V alloy showed that the matrix was alpha phase and that the large second-phase particles were beta phase. Structural features such as dislocations, dislocation networks, and stacking faults were observed in many areas in the foil, suggesting that the stacking fault energy of the alloy was rather low.

During this quarter, transmission electron microscopy studies were directed toward further characterization of Ti-8Al-1Mo-1V alloy structure. Thin foils for transmission studies were prepared from the 0.050-inch-thick sheet of duplex-annealed alloy (heat D-5657). The structural appearance of many regions of this material (Figure 8) was similar to that seen previously in foils prepared from the 0.030-inch-thick sheet of mill-annealed alloy (heat D-3420). Selected-area electron diffraction studies revealed that the matrix was the hexagonal alpha phase and that the large second phase particles in the matrix

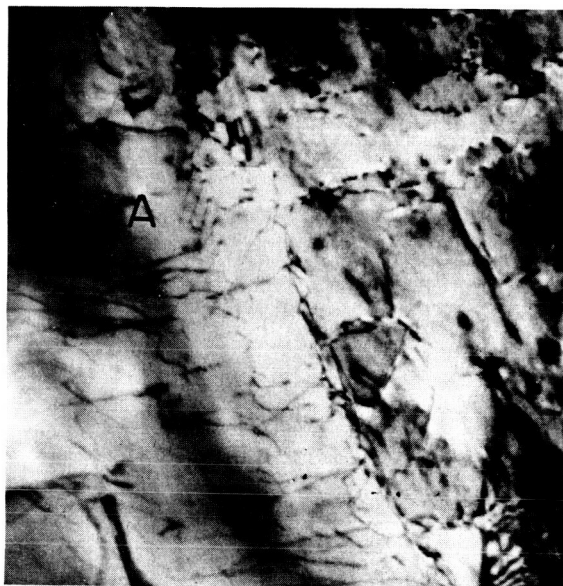
Note coplanar array of dislocations at area A

FIG. 9 DISLOCATIONS IN THE Ti-8Al-1Mo-1V ALLOY IN THE DUPLEX-ANNEALED CONDITION
